LEVEL I

ENVIRONMENTAL PROPERTY SURVEY

3321 South Pulaski Road Chicago, Illinois

Submitted on December 19, 1990

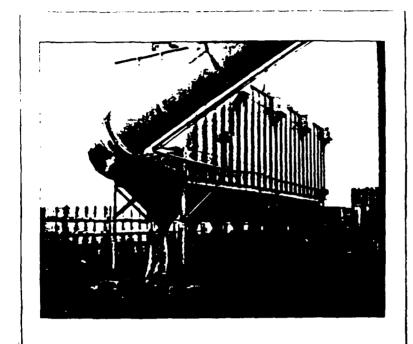
The steel building located on the east side of the property has a dust collection and bagging system (bag house) for the aluminum oxide particles released from the three natural-gas fired furnaces. The system was installed in March-April of 1989, by the previous company, Jay Armstrong Metals Co., Inc. An IEPA operating permit was obtained and transferred to Double A Metals Inc. (ID number 031600FIX). The permit also includes the two direct heating rotary furnaces and the reverb (hot box) heater. This information was confirmed by Mr. Ray Pilapil, of the IEPA air permitting section.

The bag house located north of the steel building. The bag house is used to collect aluminum oxide dust particles released during the dross processing.
